FINAL ACTION OF MAJOR INCIDENT INVESTIGATION REPORT INTO THE CIRCUMSTANCES SURROUNDING THE DEATH OF A PERSON IN THE BROWNSVILLE SHIP CHANNEL ON 24 APRIL 2015 AND THE POSSIBLE INVOLVEMENT IN THE DEATH BY A STATION SOUTH PADRE ISLAND (SPI) 33' SPC-LE SMALL BOAT

14 Jul 2015

Subj: MAJOR INCIDENT INVESTIGATION (MII) REPORT REGARDING THE DEATH
OF A PERSON IN THE BROWNSVILLE SHIP CHANNEL ON OR ABOUT 24
APRIL 2015 AND THE POSSIBLE INVOLVEMENT OF A STATION SOUTH
PADRE ISLAND (SPI) 33' SPC-LE SMALL BOAT

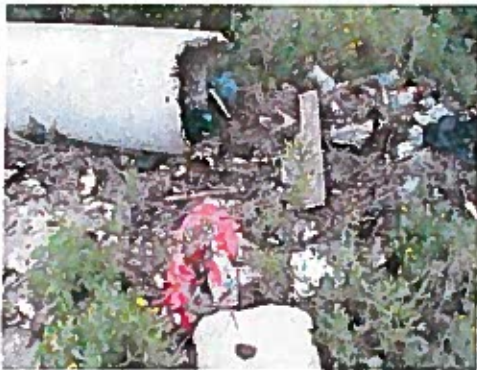
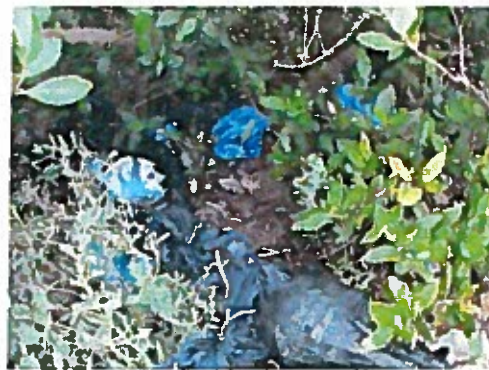
Migrant and drug smuggling activities have occurred along the length of the BSC, most commonly under the cover of darkness, at night and in the early morning. The general vicinity of the Shrimp Basin is one known area where this illegal activity occurs. Undocumented aliens and smugglers utilize a lighted cell phone tower near the Shrimp Basin as a beacon to guide them from the U.S./ Mexico border. Undocumented immigrants and smugglers typically use flotation devices, including inner tubes, to assist them to cross the BSC. The flotation devices are typically abandoned in the brush on the north side of the BSC after the crossings, see Figures 2 and 3. (Exhibits 5, 14, 15, 16, 17, 18, 27).

Figure 2 and 3 - Deflated Flotation Devices & other undocumented alien debris located on North Shoreline of BSC in the vicinity of the Shrimp Basin

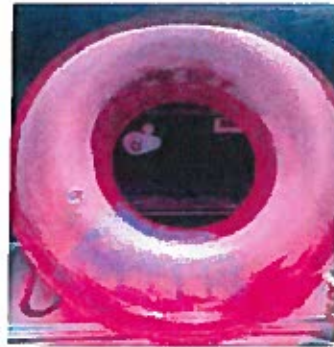
fully inflated pink plastic recreational-type inner tube. See Figure 6. After further searching concluded with negative results, the BIC and CC decided to continue on with the patrol with the implied assumption that the inner tube was the source of the sound on the hull. Throughout the search evolution, the crew did not perform Coast Guard prescribed standard procedures following a collision with a submerged object, commonly referred to as a Basic Engineering Casualty Control Exercise (BECCE) (Exhibit 37). The crew also did not contact (via radio) STA SPI to inform them that the SPC-LE had apparently struck an object. (Exhibits 2, 6, 10, 11, 12).

Figure 6 – Inner tube found in BSC

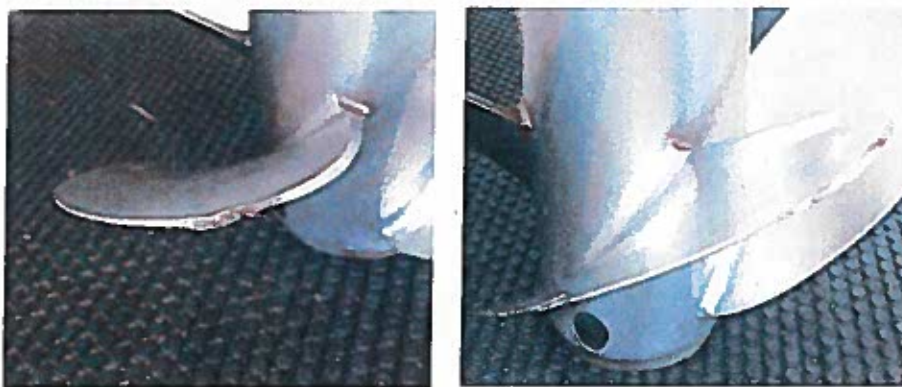
On 27 April 2015, the Cameron County Coroner conducted an autopsy on the Undocumented Alien in the presence of CGIS Special Agents. The CGIS Special Agents brought to the autopsy one of the SPC-LE's propellers, and specific measurements taken between the three outboard engines propellers. The injuries on the Undocumented Alien were consistent with the shape of the SPC-LE's propeller blades, and also the distances between the outboard engine propellers. The CGIS agents and the Coroner concluded a direct match, confirming the involvement of the SPC-LE in the incident. The Coroner concluded that the Undocumented Alien died nearly instantly because of the initial blunt force trauma and blood loss. The Coroner determined the official cause of death as Boat Propeller trauma with drowning (Exhibits 17, 39, 40).

f. Vessel Systems: Following the incident, an inspection of the three propellers from the SPC-LE revealed damage to the blades of the center propeller, see Figures 7 and 8.

Figures 7 and 8 - Visible Damage on the Center Outboard Engine Propeller
