Fire Reveals Flooding Hazard at Indian Point

Dave Lochbaum

December 2015

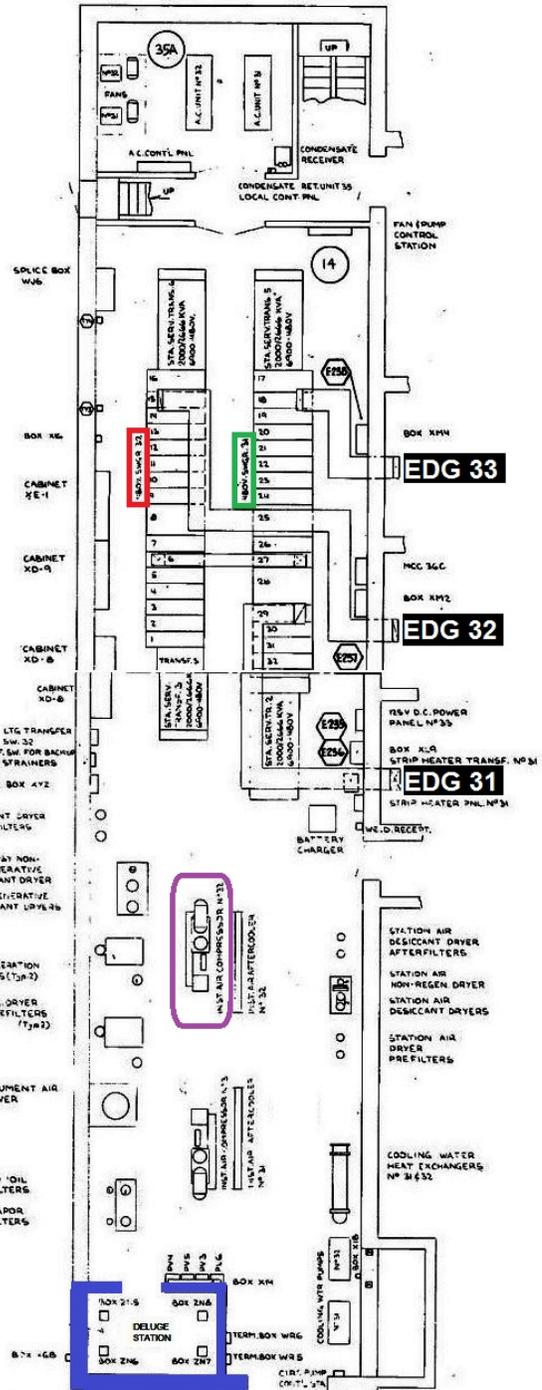
FIGURE 2. Switchgear Room for Unit 3

The switchgear room also houses other equipment. The deluge valves are located within the deluge station room outlined in blue. A 10-inch diameter pipe is connected to the four valves at the deluge station that control the flow of fire suppression water to the main, auxiliary, and station transformers.

Two instrument air compressors, one circled in purple, are in the room.

Two air conditioning units are located in the area next to the stairwells at the upper end of the room. A 2-inch diameter pipe supplies cooling water to these air conditioning units. A 6-inch high curb installed at the doorway to the switchgear room protects the switchgears from flooding caused by rupture of this cooling water pipe.

At the same time (6:12 pm), the control room operators received reports of water on the floor of the switchgear room, which is located on the first floor of the control building (see Figure 2).

Workers initially reported one to two inches of water on the switchgear room floor. But instrument air compressor 32 within the switchgear room (circled in purple in Figure 2) had its own flood protection barrier that was one inch tall. The dry floor inside this barrier proved that the water level in the switchgear room never rose above one inch to spill over into this area.

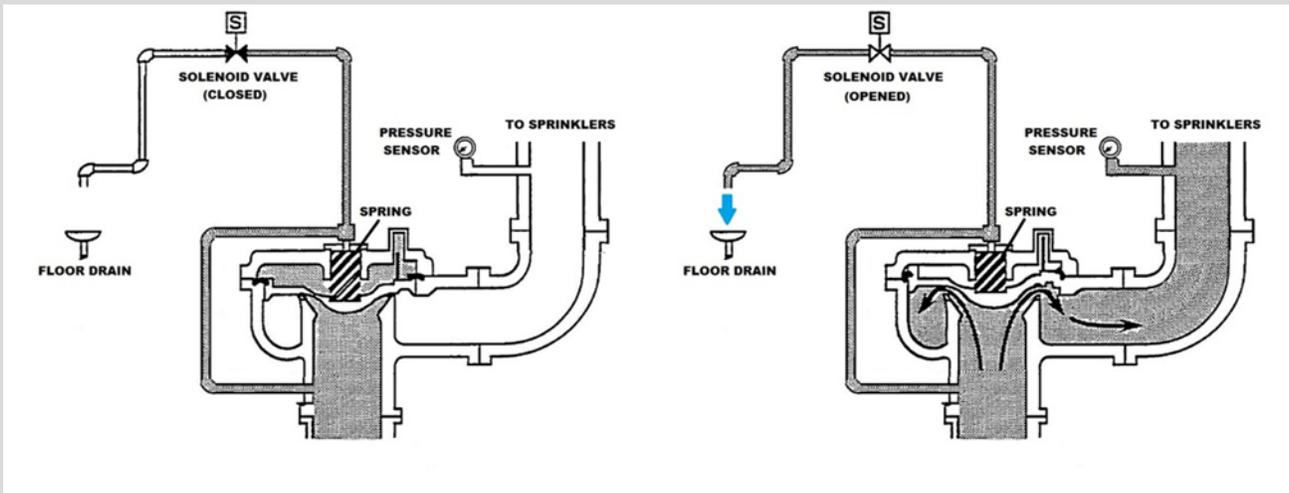
How Indian Point's Deluge Valves Work—and Stopped Working

The schematic on the left shows a closed deluge valve. Water from the fire protection system pipe flows through a small tube around the deluge valve until it is stopped by the closed solenoid valve. The closed solenoid valve causes the water pressure on both sides of the deluge valves' diaphragm (also called a flapper) to equalize. The spring force acting on the upper side of the diaphragm holds it closed, preventing the flow of water through the pipe to the sprinklers.

Manual or automatic actuation of the deluge system energizes the solenoid valve and opens it to allow water on the upper side of the diaphragm to flow through the vent and enter the floor drain, as shown in the figure on the right. The water pressure on the upper side of the diaphragm drops low enough that the fire protection system's water pressure overcomes the spring force, pushing the diaphragm to the opened position. Fire protection system water flows through the pipe to the sprinklers to spray onto the transformer. The water flow (and pressure) is monitored by a sensor in the discharge pipe. At a certain pressure, the sensor sends a signal that de-energizes the solenoid valve, closing it.

With the solenoid valve closed, the pressure on both sides of the diaphragm equalizes. But the spring force does not drive the diaphragm closed again until a retainer pin (shown to the right of the spring) is manually reset. This retainer pin engages when the diaphragm opens to permit flow to the sprinklers until it is reset.

Debris and corrosion in the tubes to the pressure sensors prevented them from detecting the pressure in the discharge pipes and signal the solenoid valves to close. Consequently, water continued to flow through the open solenoid valves onto the switchgear room floor.
