FINAL ACTION OF MAJOR INCIDENT INVESTIGATION REPORT INTO THE CIRCUMSTANCES SURROUNDING THE DEATH OF A PERSON IN THE BROWNSVILLE SHIP CHANNEL ON 24 APRIL 2015 AND THE POSSIBLE INVOLVEMENT IN THE DEATH BY A STATION SOUTH PADRE ISLAND (SPI) 33' SPC-LE SMALL BOAT

14 Jul 2015

Subj: MAJOR INCIDENT INVESTIGATION (MII) REPORT REGARDING THE DEATH
OF A PERSON IN THE BROWNSVILLE SHIP CHANNEL ON OR ABOUT 24
APRIL 2015 AND THE POSSIBLE INVOLVEMENT OF A STATION SOUTH
PADRE ISLAND (SPI) 33' SPC-LE SMALL BOAT

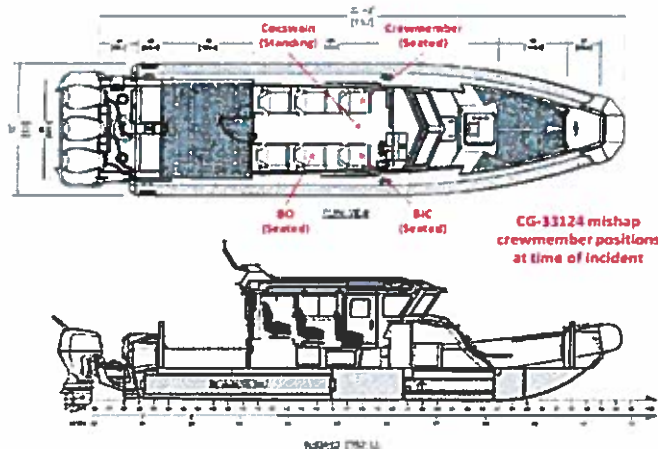
Figure 4 - Seating Arrangement for SPC-LE

At some point after entering the channel and at the beginning of the patrol, the CC allowed the Crewmen to sit in the forward, port side "navigator" seat and operate the Maritime Forward Looking Infrared (MarFLIR) system. From that point in time, the CC stood upright between the navigator and the BIC for the duration of the patrol (Exhibits 6, 12). See Figure 4.

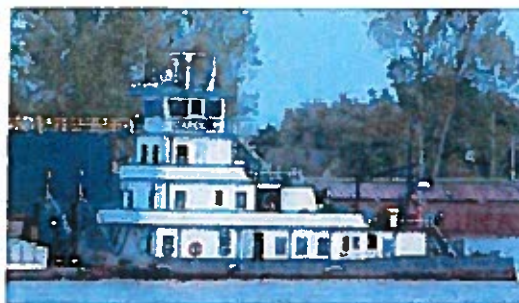
Figure 5 - Towing Vessel CAROL M

The patrol proceeded without incident to a location within the BSC in the vicinity of the Jaime Zapata Boat Ramp. As the SPC-LE approached this area, at approximately 10:30 p.m., the CC visually acquired an approaching Uninspected Towing Vessel (UTV), UTV CAROL M (see Figure 5), that was outbound in the BSC pushing four empty barges, (Exhibit 6). The CC radioed to the UTV CAROL M on VHF to arrange for a port-to-port passing agreement (Exhibits 6, 23). The towing vessel operator responded in agreement, and also informed the CC that he could not see the boat's navigational lights (Exhibits 6, 23). At this time, the CC realized that the BIC had mistakenly energized the aft starboard flood light, and not the navigation lights (Exhibits 6, 10). The switch for the aft starboard flood light is located to the immediate left of the switch for the navigational lights on the boat's overhead instrument panel (OHIP). The OHIP is located directly above the coxswain seat (Exhibits 22, 24). The CC turned off the aft starboard flood light and energized the navigation lights (Exhibits 6, 10). The operator of the UTV CAROL M confirmed that he saw the navigation lights of the SPC-LE energized. He also confirmed that he visually saw the navigation lights for at least a mile after the passing occurred, at which time he concentrated his attention only forward of his tow (Exhibit 23).

Since the UTV CAROL M was pushing ahead four empty open hopper barges arranged in a two by two configuration, the SPC-LE gave a wide berth by moving to the north side of the navigable channel and slowed speed from nine knots to approximately four knots, (Exhibits 6, 10, 23, 25). The SPC-LE and UTV CAROL M passed each other at approximately 10:36 p.m. (Exhibits 25, 26, 28).
