Fire Reveals Flooding Hazard at Indian Point

Dave Lochbaum

December 2015

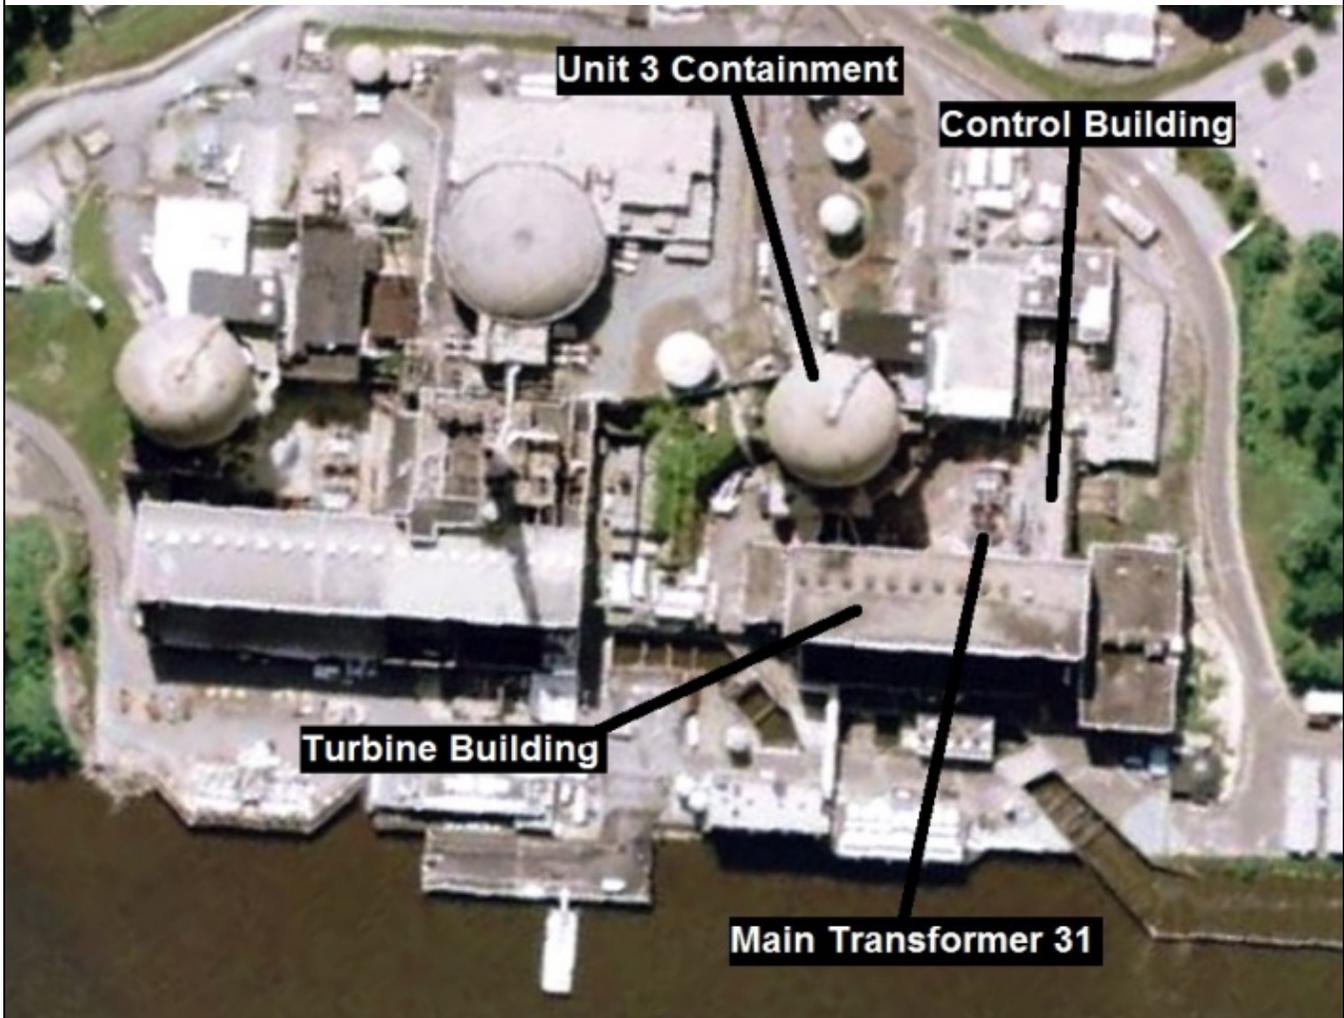
FIGURE 1. Satellite View of Indian Point Energy Center

The explosion of main transformer 31 on May 9, 2015 shut down the Unit 3 reactor and turbine, and led to flooding of the switchgear room on the ground floor of the control building.
